DRUM Project: Best Practice

Case study of installation of fault passage indicator

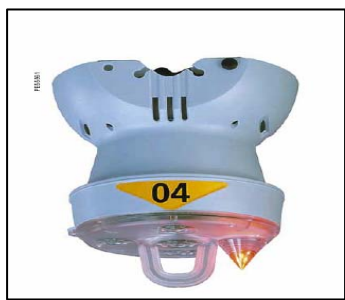
Fault Passage Indicator

In order to address the above issue, the D.P.R. for DRUM initiatives at Umreth site envisaged to install Fault Passage Indicators (F.P.I.) on strategic locations of 11 KV feeders. The F.P.I. are installed on over head conductor at the beginning of all tap lines and at logical sections of the feeder. In case of occurrence of fault, the F.P.I. in the path of fault current glows and indicates the path of fault current and thus leads to the location of fault. This coupled with the effective communication (cell phone provided to the field staff) helps locating the faulty section expeditiously and thereby faster restoration of the supply in the healthy part of the feeder.

The blinking pattern of F.P.I. is different for transient and sustained fault.

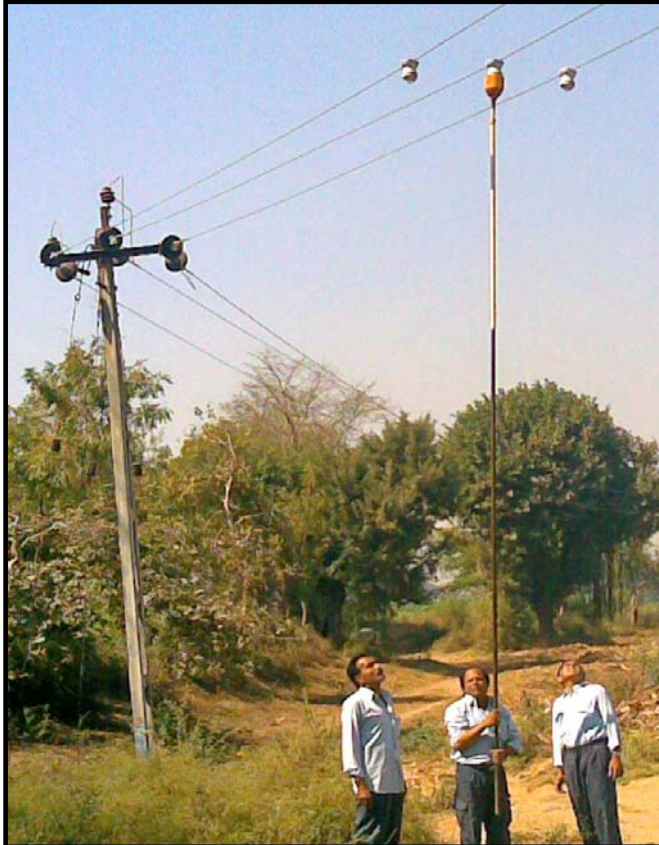
Installation

Power to villages of DRUM Site at Umreth is supplied through 18 11Kv feeders. 720 FPIs are installed on carefully selected strategic locations on these feeders. The installation procedure is simple and does not require shutdown of feeder. The work was completed in 15 days.

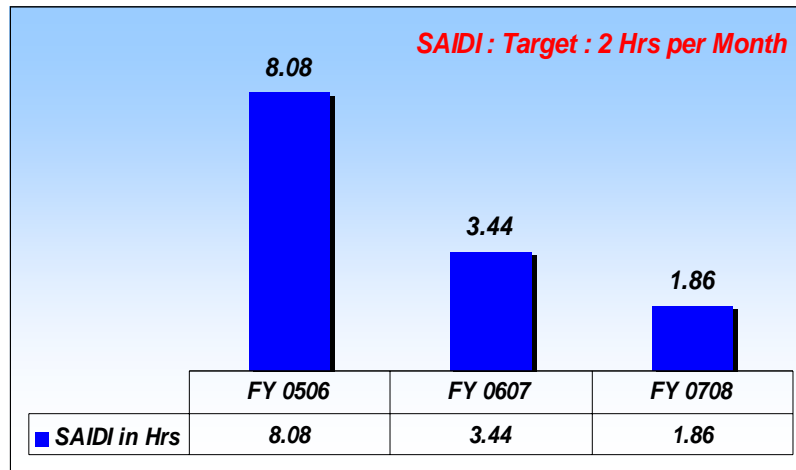
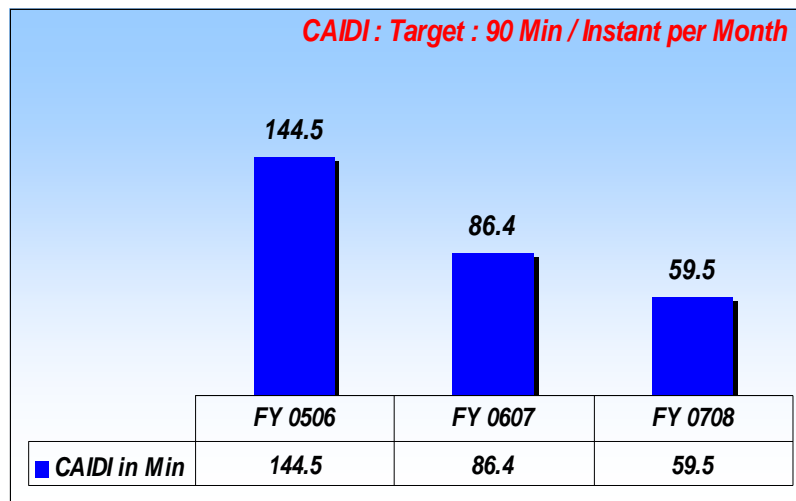
This has significantly improved the reliability of power supply to rural areas. The following charts indicate the improvement achieved in CAIDI and SAIDI of the reliability indices.

It is observed that on an average, it was taking 2 to 6 hours to restore the supply depending on the length of the feeder, location of fault and available communication. On installation of FPIs and effective communication, this reduced to 30 minutes to 1 hour.
